Slope Stability Analysis to Evaluate Slope Failure in Northern Thailand by Standard Penetration Test

Patthranit Payaksiri^{a*}, Sayam Aroonsrimorakot^a, Pet Pakchotanon^b, and Bunlur Emaruchi^c

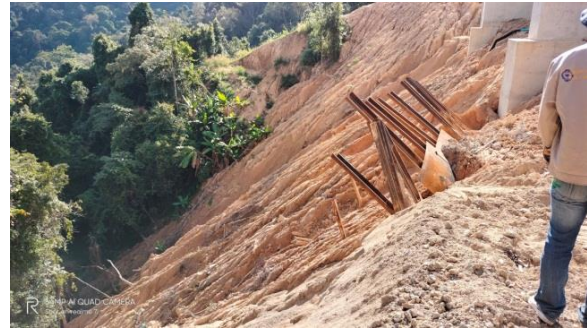
Figure 7. Show the area and nature of the failure of a slopes in Highway No.1263, section Khun Yuam - Pang Ung, at about 18+580 km LT.

4.2.1 Erosion failures as shown in Figure 7 are based on the Infinite Slope stability analysis equation.

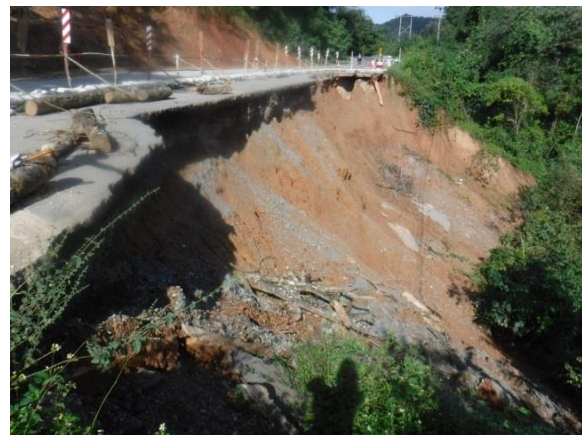
Figure 8. Show the area and nature of the failure of a slopes in Highway no. 108, section Mae Rid Bridge-Huai Ngu at km. 158+865 - km.158+923 RT.

4.2.2 Circular failure as shown in Figure 8 using Bishop's Simplified Method slope stability analysis equation.
